TROUBLESHOOTING: LOOKING BEYOND THE OBVIOUS

by: Michael Edwards June 2010

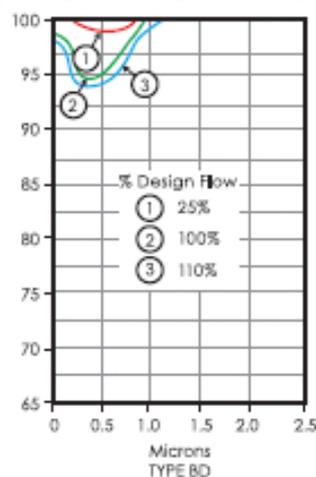
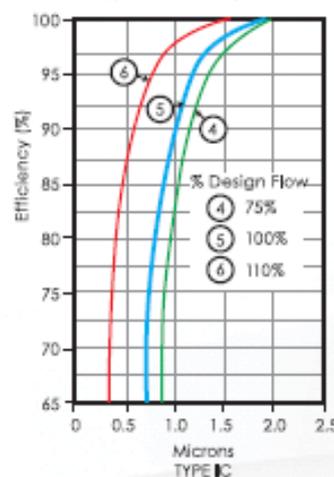
Unfortunately, the “conservative” design meant that the KO pot was operating all the time below the design demister flow rate (and most of the time below the maximum rate for the expansion project). That translates to efficiencies of droplet collection at or below curve 4 above, which was particularly low with the finer droplets. Returning to the original project basis for design and switching to “Brownian Diffusion” style of demister pad, the surface area was greatly increased, but the efficiency was much improved, and almost completely insensitive to turndown flow rates. Higher collection efficiencies than the other style demister were achievable even above project max rates (compare curve 3 with curve 6). A general lesson can also be seen here: Conservative design does not always mean over-design, especially in such items as cyclones (efficiency drops rapidly below design rate) and exchangers in fouling service (low flow rates promote the very fouling feared in the first place).
